TAMU Project

**Energy Consumption Data Quality Assurance/Quality
Control Assessment Report for the
Month of September 2016**

**Utility & Energy Services
Division of Administration
Texas A&M University**

October 2016

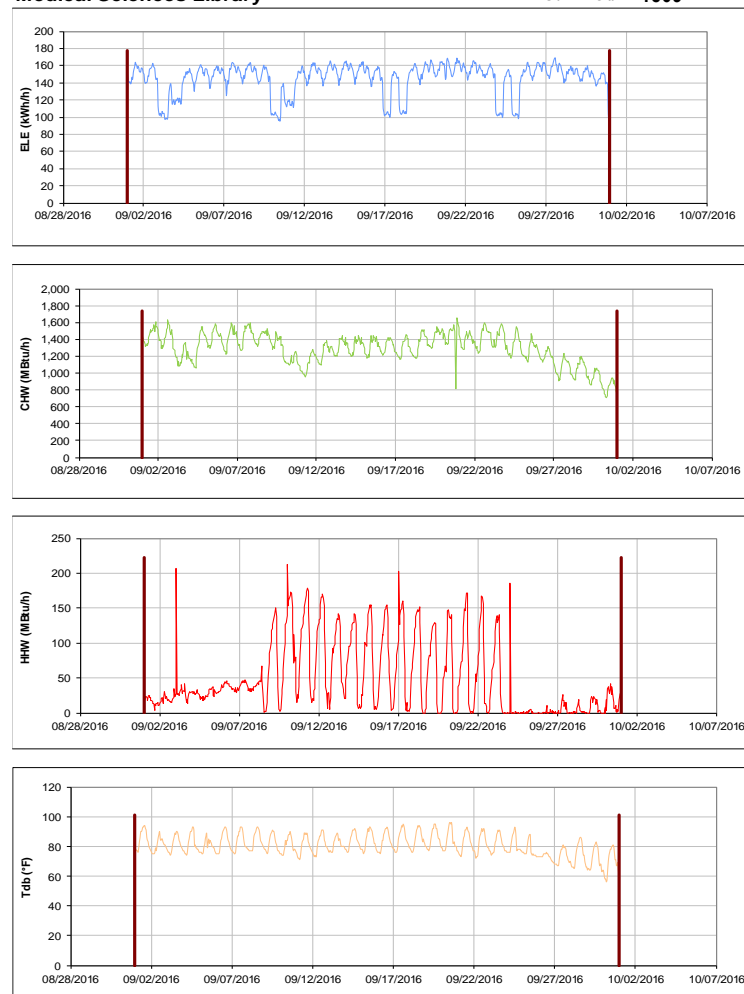
Medical Sciences Library TAMU / BLDG #: 1509

Figure III-156 Hourly Whole Building Electricity, Chilled Water, and Hot Water Consumption for Medical Sciences Library during the Month of September 2016 and the Corresponding Hourly Outdoor Dry Bulb Temperature for College Station, TX

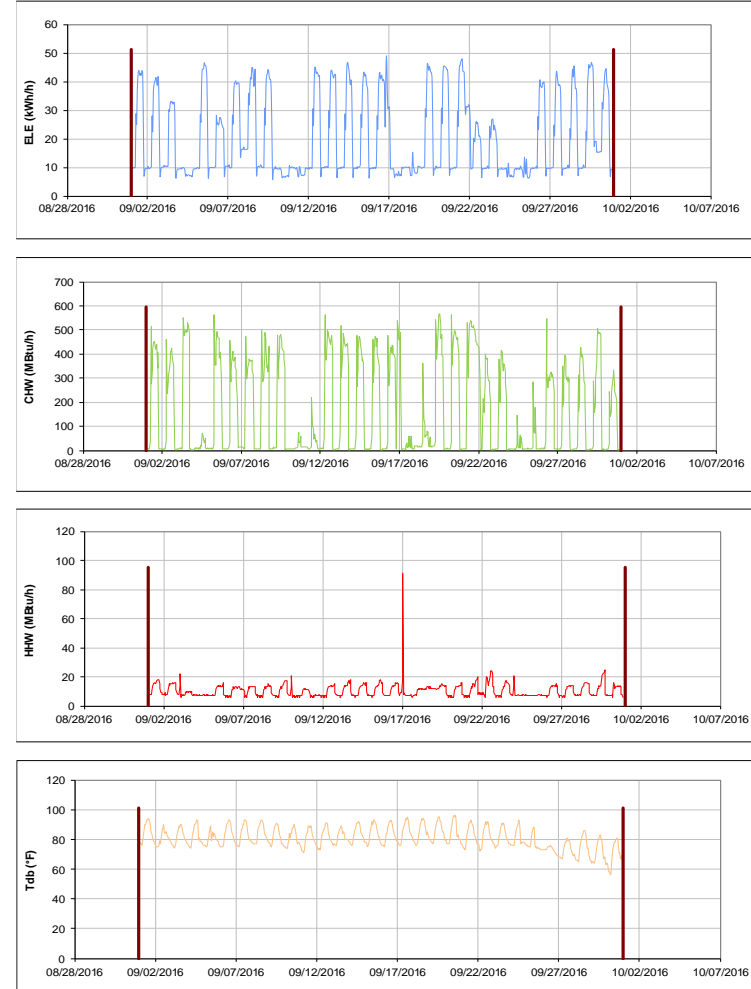
TAMU / BLDG #: 1538

Figure III-166 Hourly Whole Building Electricity, Chilled Water, and Hot Water Consumption for Agriculture Program Visitors Center during the Month of September 2016 and the Corresponding Hourly Outdoor Dry Bulb Temperature for College Station, TX

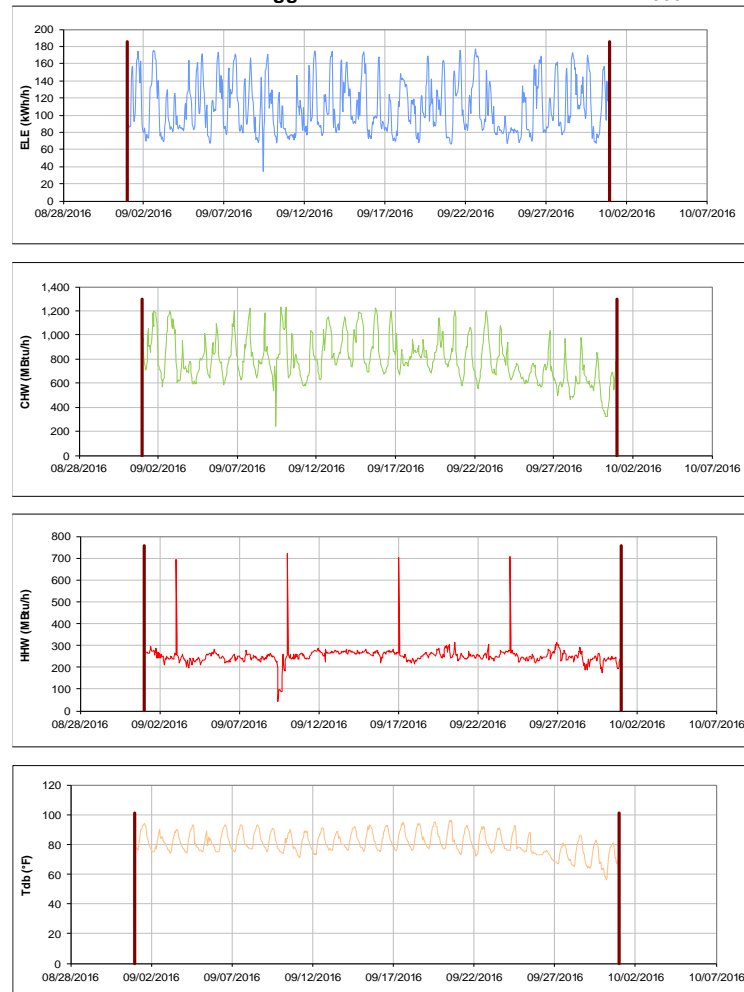
Cox-McFerrin Center for Aggie Basketball TAMU / BLDG #: 1558

Figure III-170 Hourly Whole Building Electricity, Chilled Water, and Hot Water Consumption for Cox-McFerrin Center for Aggie Basketball during the Month of September 2016 and the Corresponding Hourly Outdoor Dry Bulb Temperature for College Station, TX

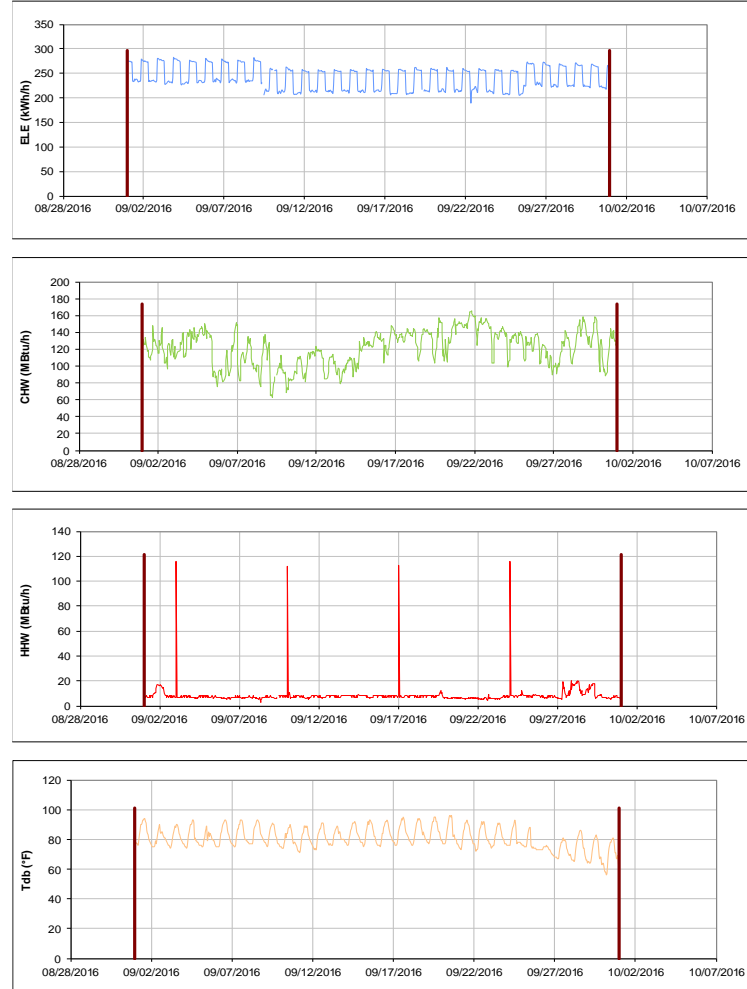
TAMU / BLDG #: 1559

Figure III-171 Hourly Whole Building Electricity, Chilled Water, and Hot Water Consumption for West Campus Parking Garage during the Month of September 2016 and the Corresponding Hourly Outdoor Dry Bulb Temperature for College Station, TX

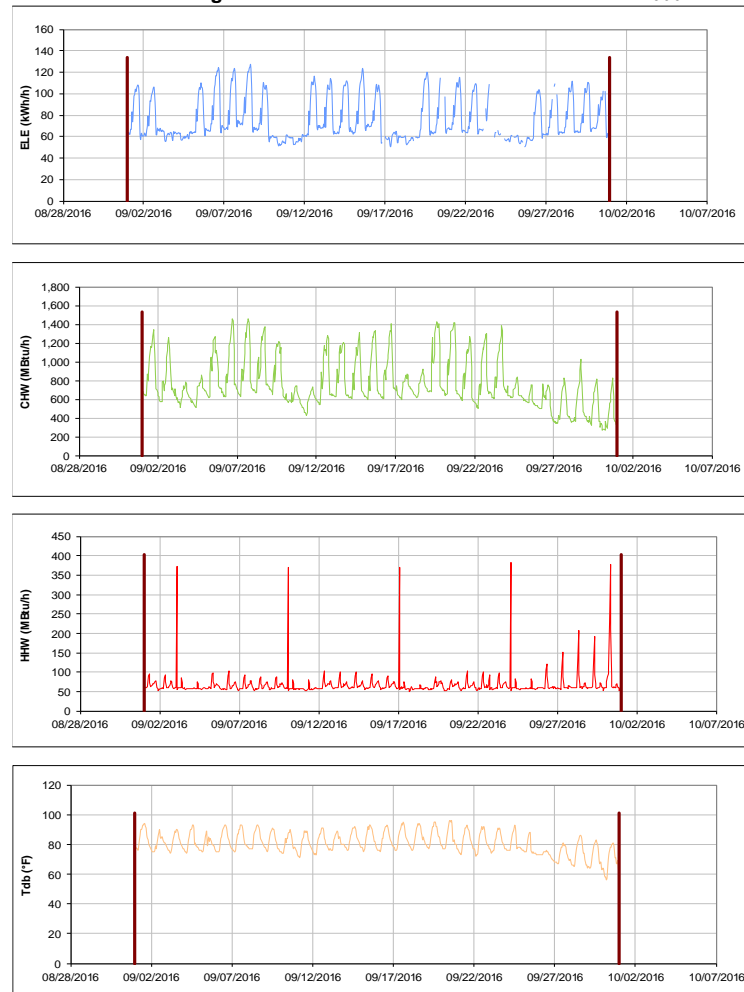
TAMU / BLDG #: 1600

Figure III-176 Hourly Whole Building Electricity, Chilled Water, and Hot Water Consumption for Gilchrist TTI Building during the Month of September 2016 and the Corresponding Hourly Outdoor Dry Bulb Temperature for College Station, TX

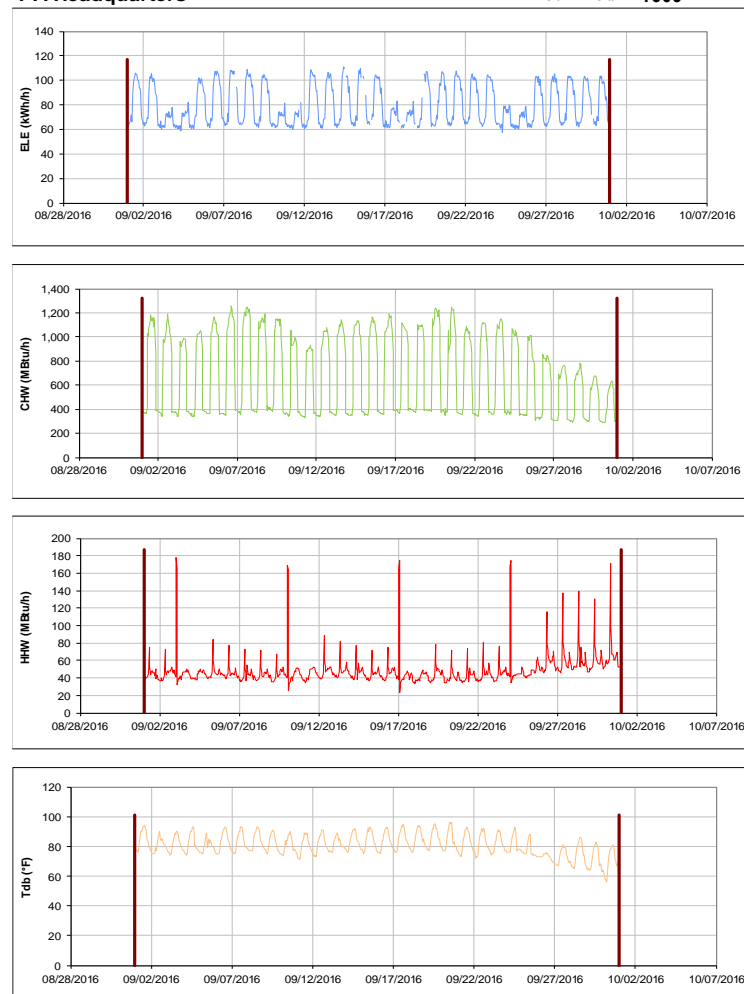
TTI Headquarters TAMU / BLDG #: 1609

Figure III-182 Hourly Whole Building Electricity, Chilled Water, and Hot Water Consumption for TTI Headquarters during the Month of September 2016 and the Corresponding Hourly Outdoor Dry Bulb Temperature for College Station, TX

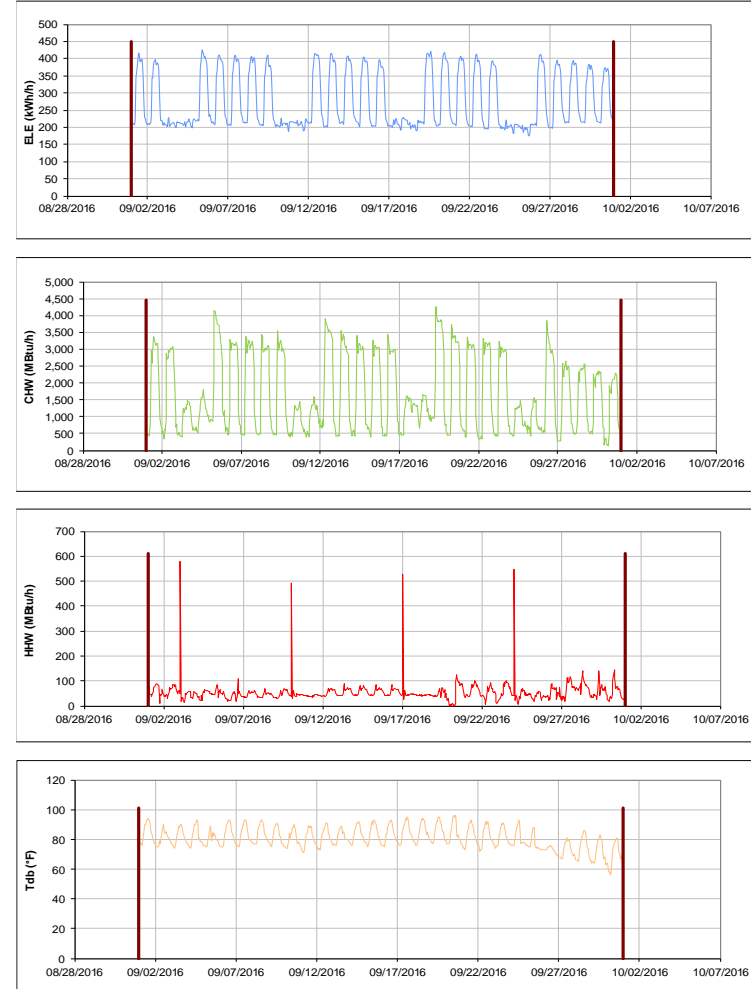
TAMU / BLDG #: 1800

Figure III-184 Hourly Whole Building Electricity, Chilled Water, and Hot Water Consumption for General Services Complex during the Month of September 2016 and the Corresponding Hourly Outdoor Dry Bulb Temperature for College Station, TX

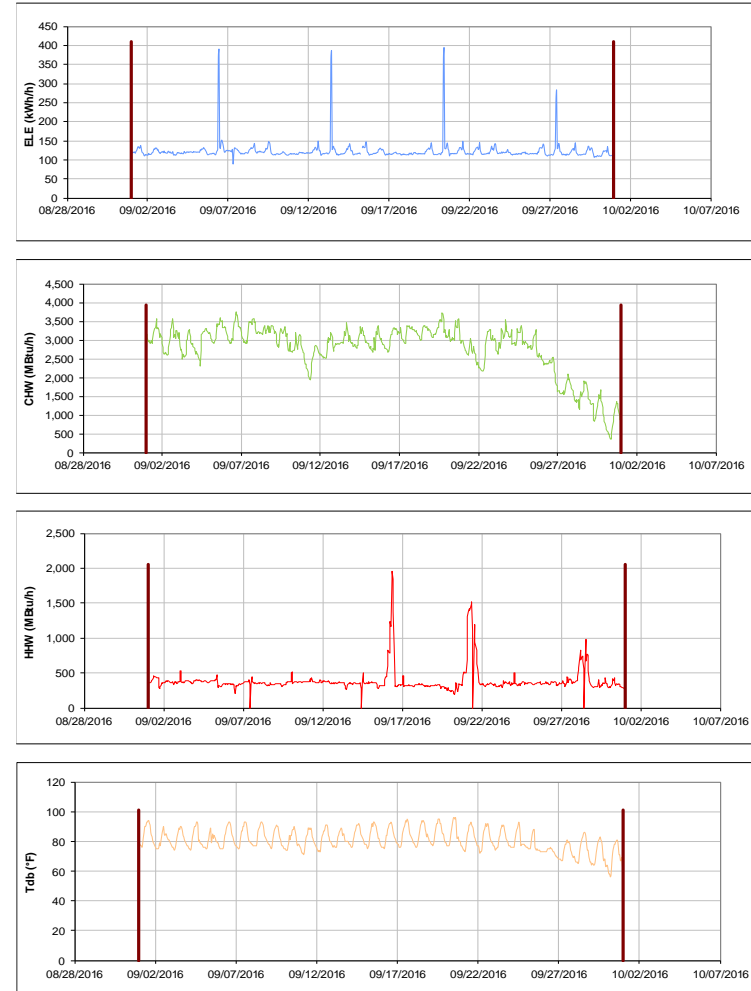
TAMU / BLDG #: 1900

Figure III-188 Hourly Whole Building Electricity, Chilled Water, and Hot Water Consumption for Texas Institute for Genomic Medicine during the Month of September 2016 and the Corresponding Hourly Outdoor Dry Bulb Temperature for College Station, TX

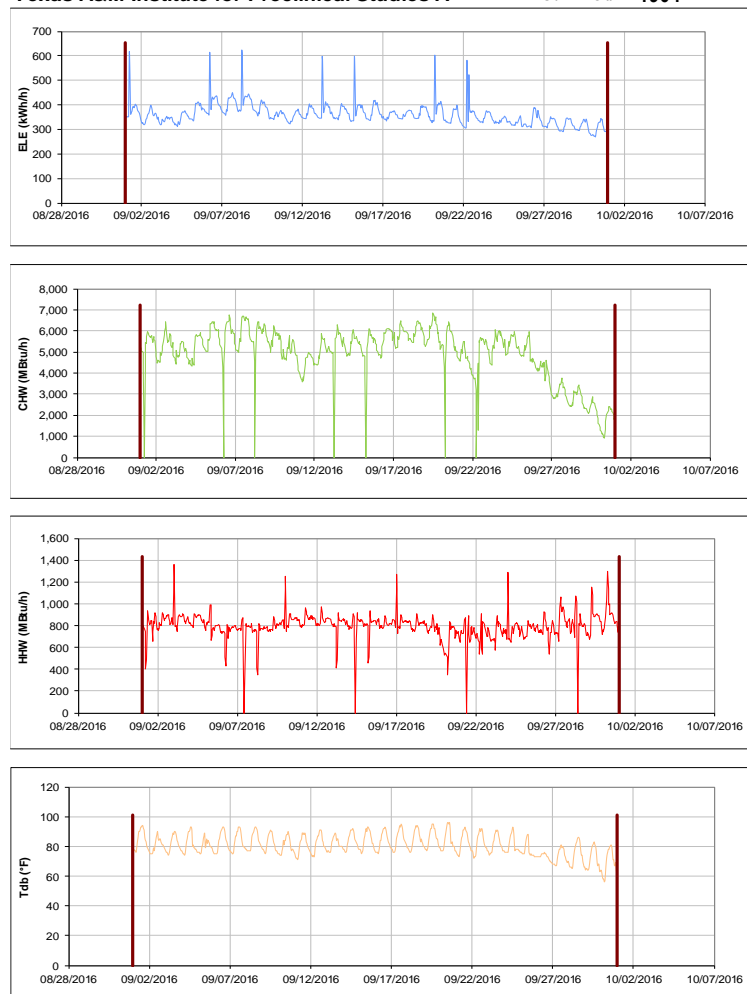
Texas A&M Institute for Preclinical Studies A TAMU / BLDG #: 1904

Figure III-189 Hourly Whole Building Electricity, Chilled Water, and Hot Water Consumption for Texas A&M Institute for Preclinical Studies A during the Month of September 2016 and the Corresponding Hourly Outdoor Dry Bulb Temperature for College Station, TX
